# Miscellaneous broken stud, pin, tap removal examples.

## The AGB Portable EDM Model 2

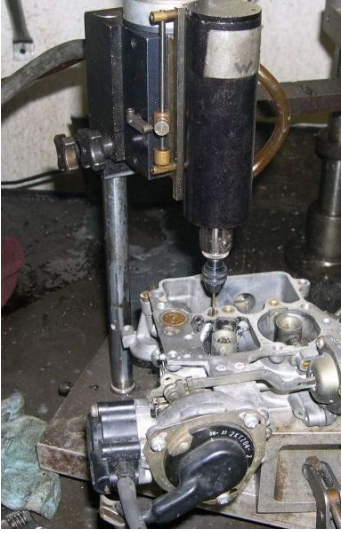
Carburetor with small needle valve screw to be removed. Electrode: .062" Brass tubing. Time: 2 min-

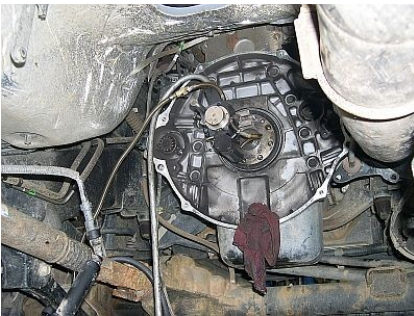
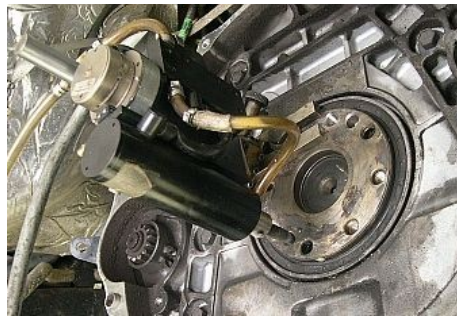
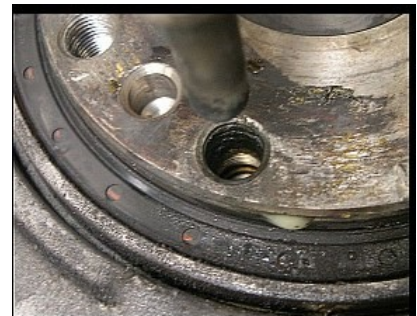
Job: Broken stud in crankshaft end plate. Engine is in vehicle and on a lift with transmission and flywheel removed (photo 1). Machine is set up using a neighbor threaded hole in crankshaft (photo 2). Hole after EDM work and before picking out remaining thread sleeve Electrode: Graphite tube 10 mm stud 20 mm deep Time: 12 minutes. Last photo shows stud removed and ready to pick out remainder of thread sleeve .

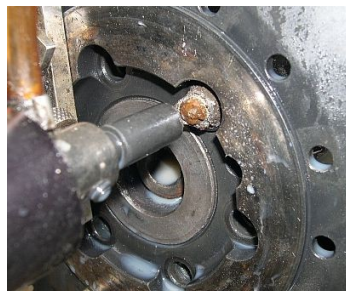
Job: EDM stripped head of ring gear bolt. Then unscrew bolt by hand. Again, working under lift. Rear of engine shown. Electrode Graphite Tube 5/8 OD x 3/8 ID Time = 6 minutes
