# Pickings from extractions

## The AGB Portable EDM Model 2

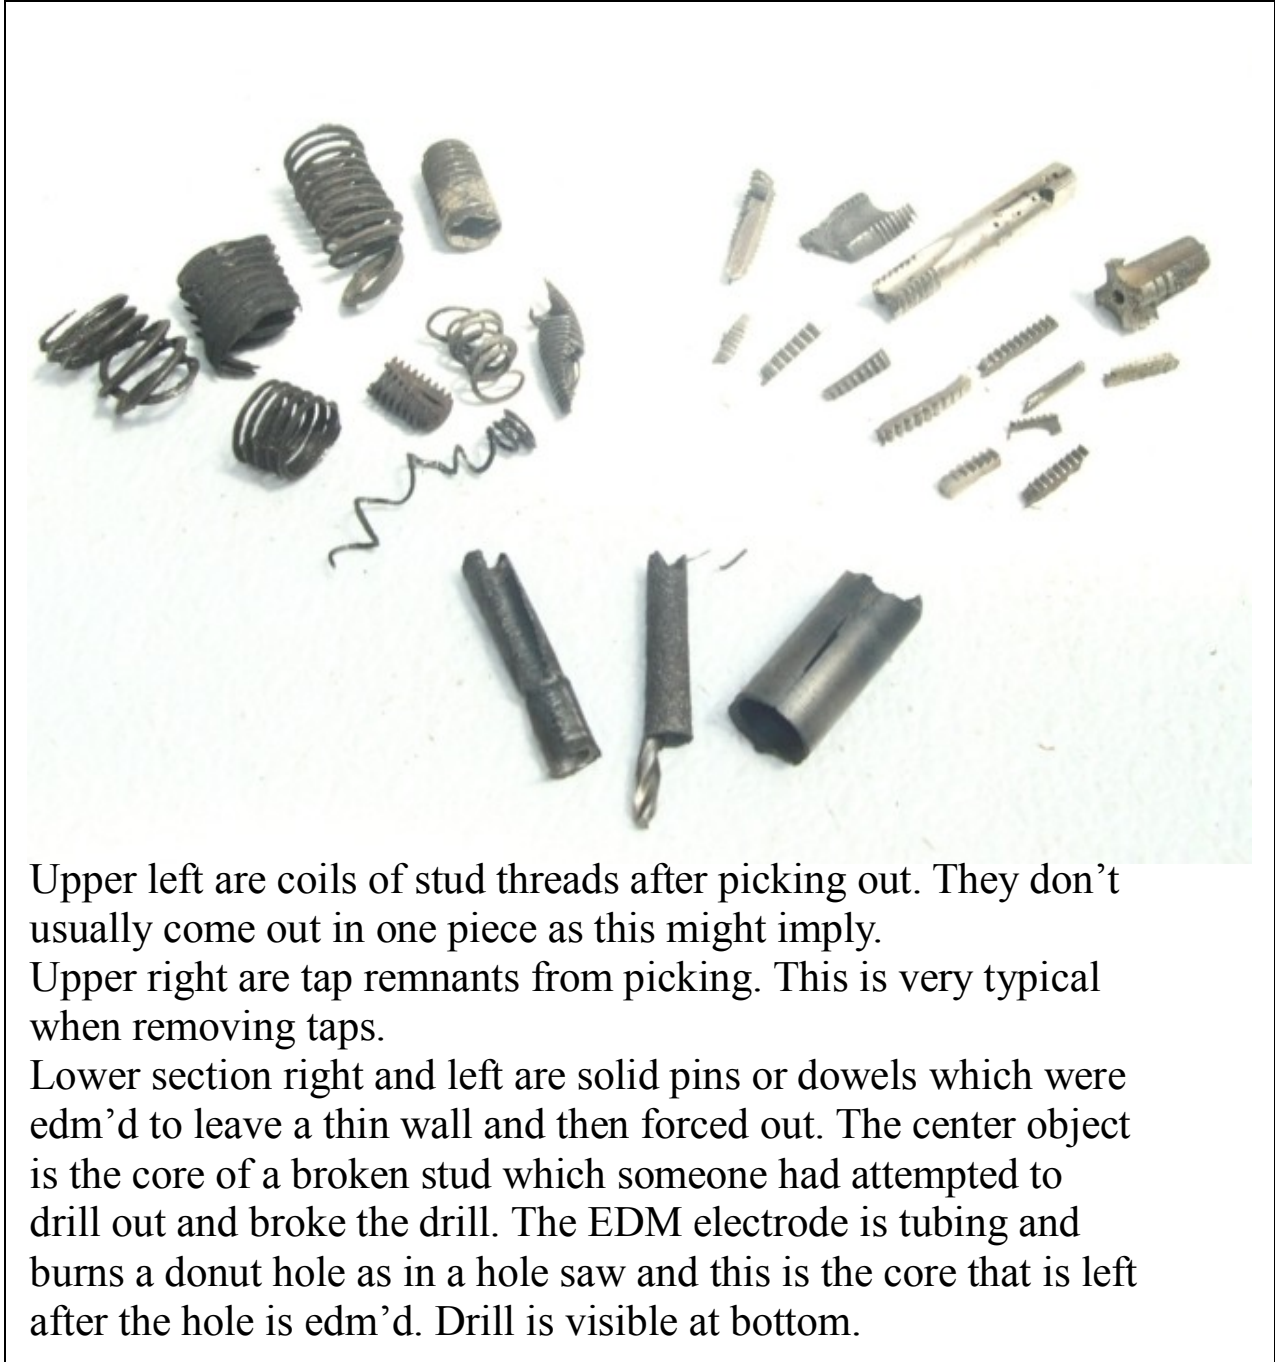
Upper left are coils of stud threads after picking out. They don't usually come out in one piece as this might imply.

Upper right are tap remnants from picking. This is very typical when removing taps.

Lower section right and left are solid pins or dowels which were edm'd to leave a thin wall and then forced out. The center object is the core of a broken stud which someone had attempted to drill out and broke the drill. The EDM electrode is tubing and burns a donut hole as in a hole saw and this is the core that is left after the hole is edm'd. Drill is visible at bottom.
